Inspection Report

Minerals Regulatory Program

Mine Name: Velvet
Operator Name: U. S. Energy

Permit number: M0370040
Inspection Date: August 29, 2006
Time: 2:00-4:40 PM (returned on the morning of August 30 to use the GPS and determine acreages)

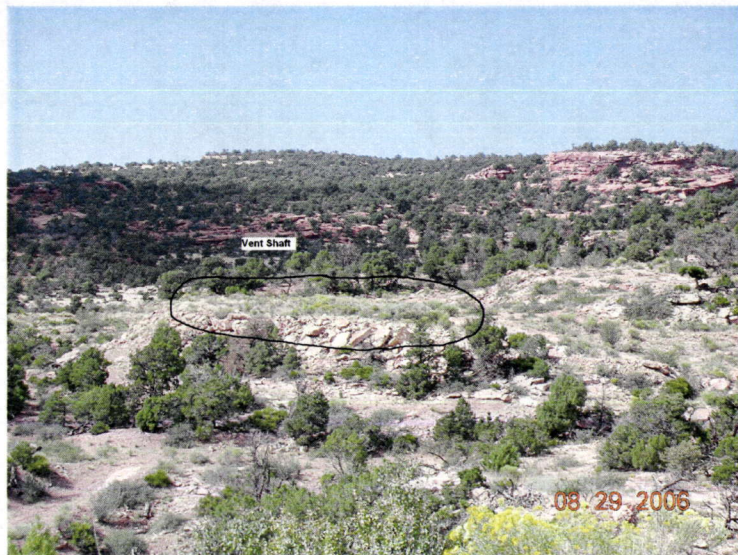
I did not measure vegetation cover at the vent shafts, but these areas looked very good (Photos 5-7).

Photo 5. The circled area is the site of one of the vent shafts.

I suggest that the operator apply for full release of the areas where vegetation cover appears to be adequate. At the mine site, the amount of vegetation on top of the pad has decreased markedly over the past year, possibly due to a large increase in the number of rabbits. When the rabbit population stabilizes, this area may recover.

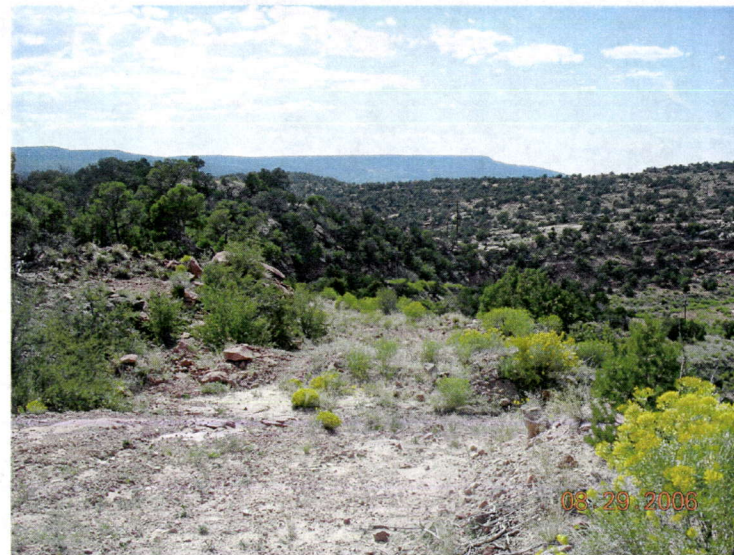
Photo 7. One of the roads leading to the vent shafts.

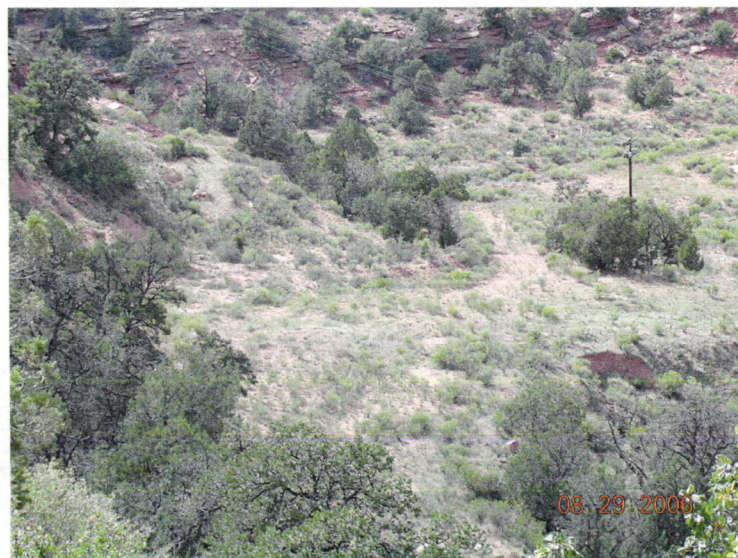
Photo 6. This is the area where another vent shaft was located.

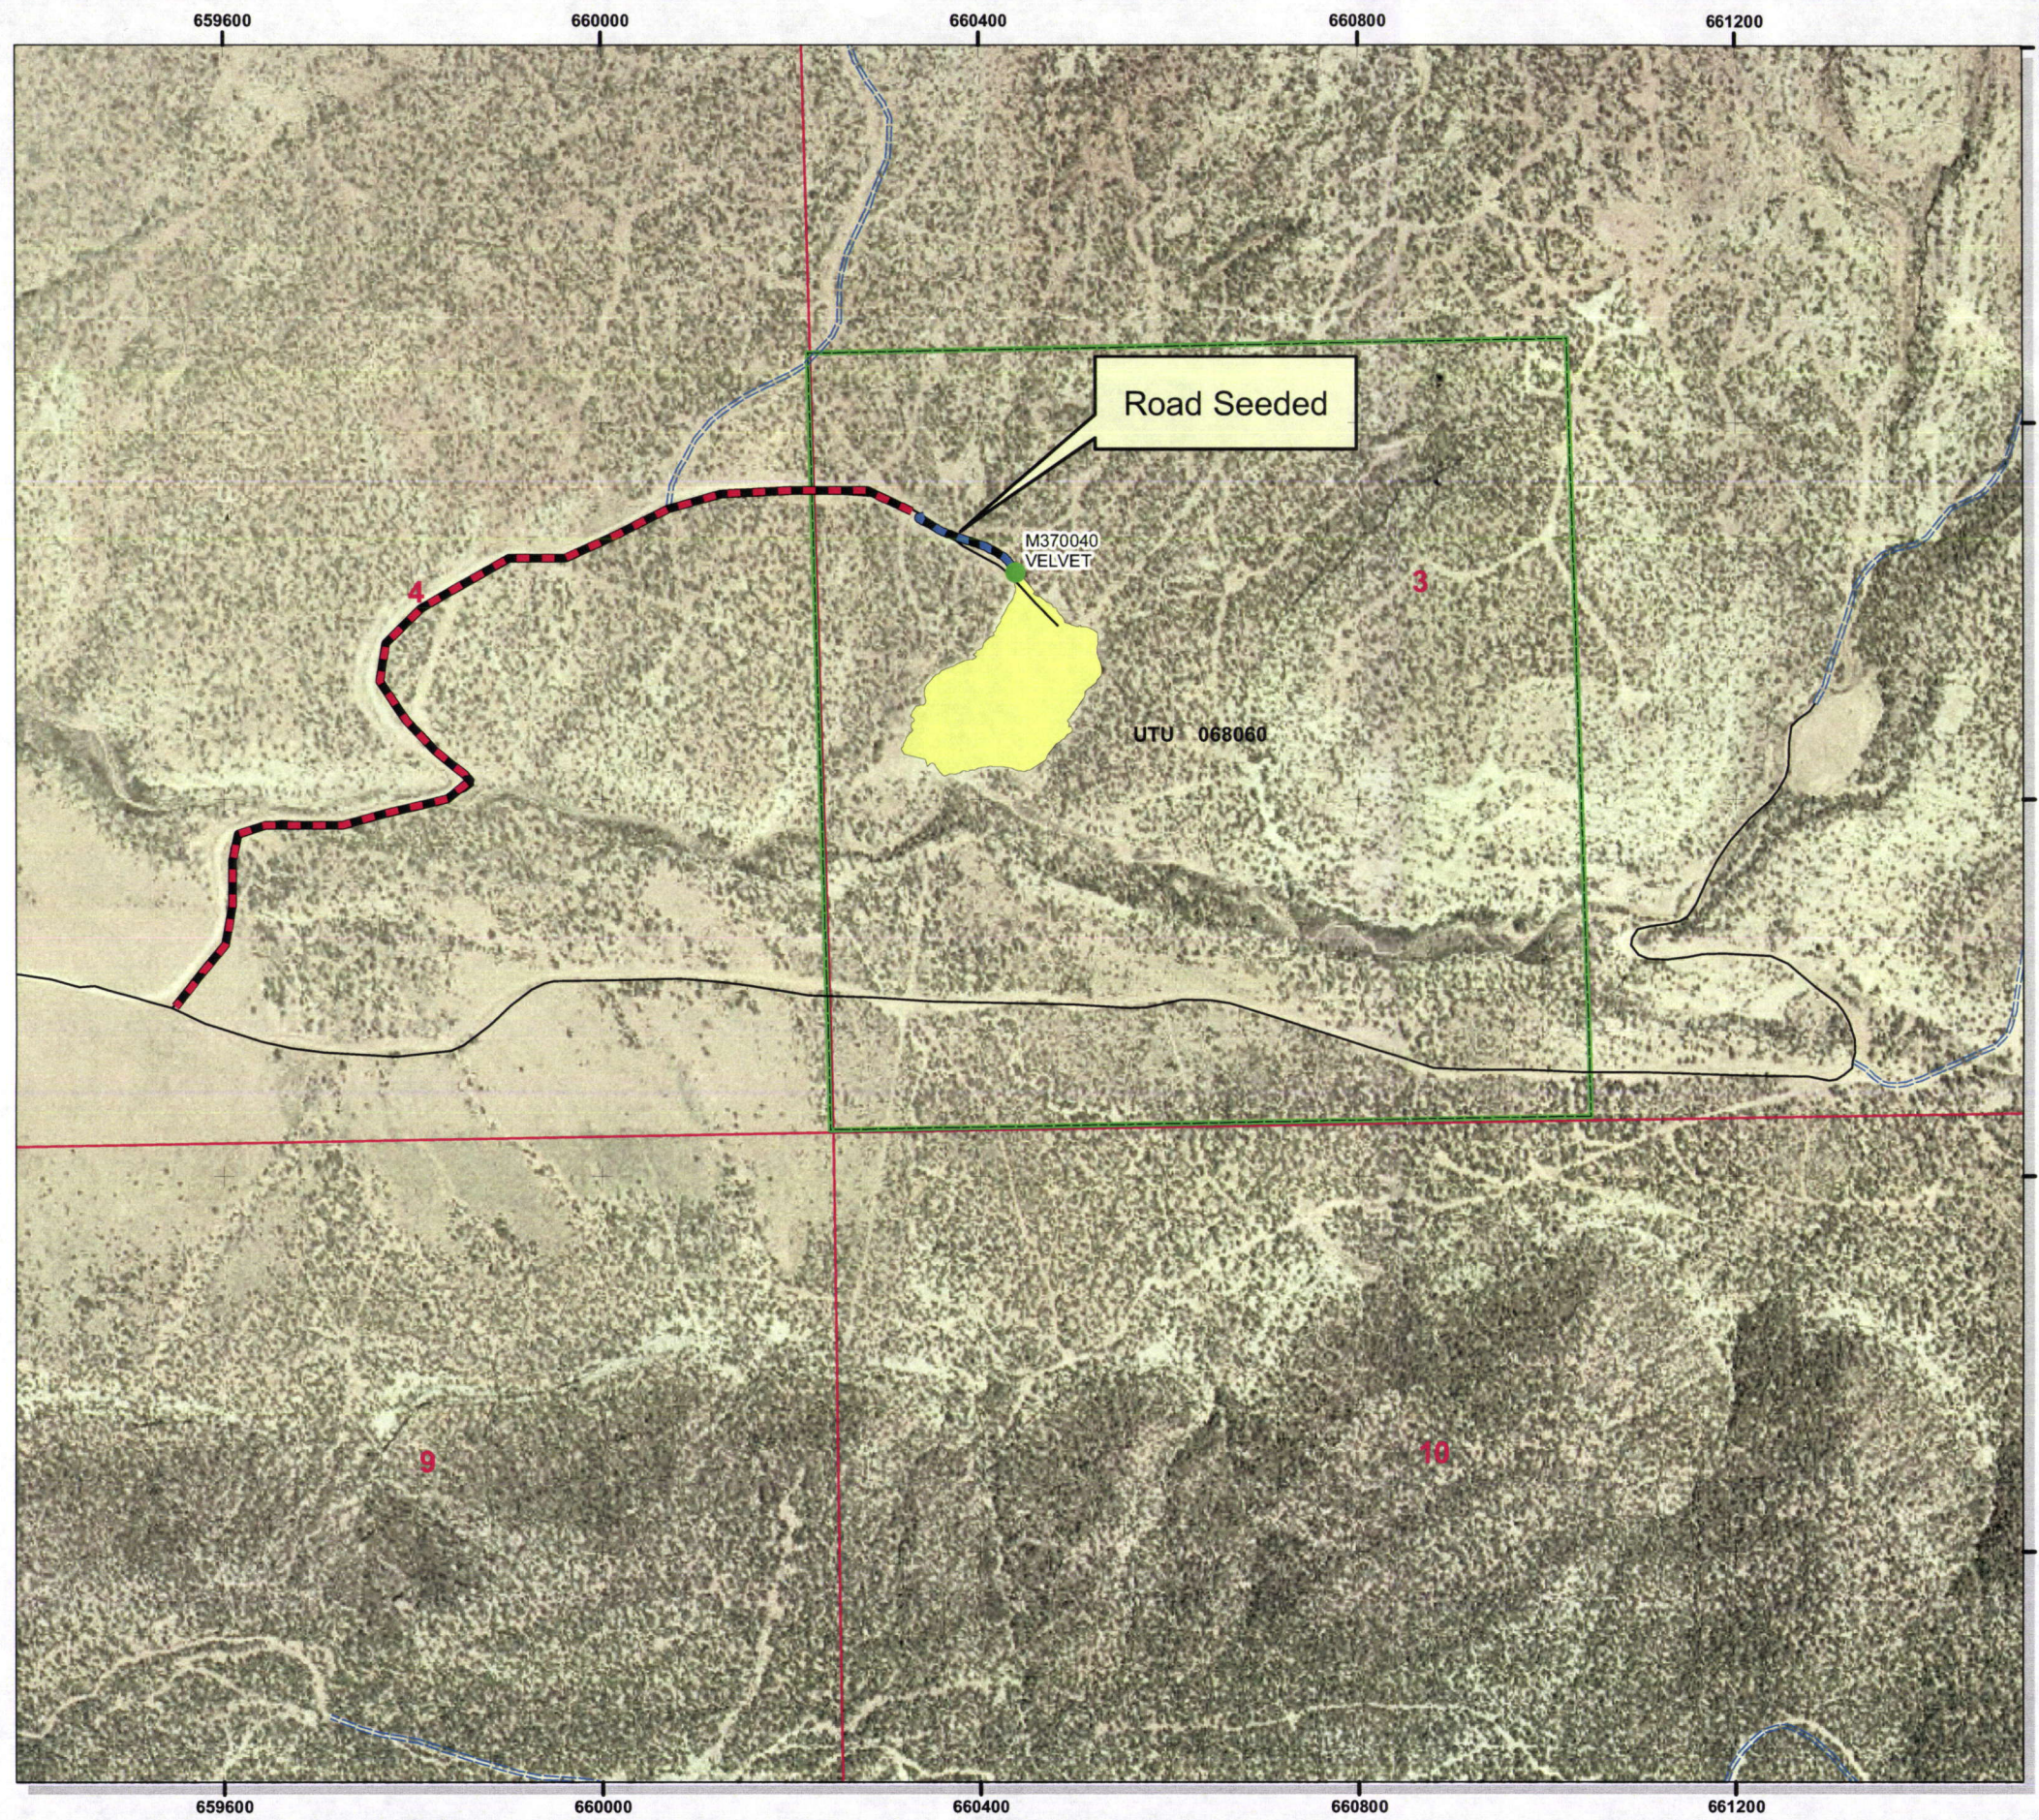
Mine Number: M0370040
Mine Name: Velvet
Township 31 S Range 25 E Section 03 SLBM

On August 30, I came back to the mine and used a GPS to measure the acreages of the access road and the main portal/pad/waste dump area. I used these numbers to weight the vegetation cover figures. The attached map shows the mapped area and the acreage figures.

Mean vegetation cover on the access road was 38.0 percent, and in the mine area it was 7.3 percent. The weighted mean for this area is 8.9 percent.
